PHYSICOCHEMICAL ASPECTS OF GUN BARREL EROSION AND ITS CONTROL

SEPTEMBER 1975

TECHNICAL REPORT

IQUAL AHMAD

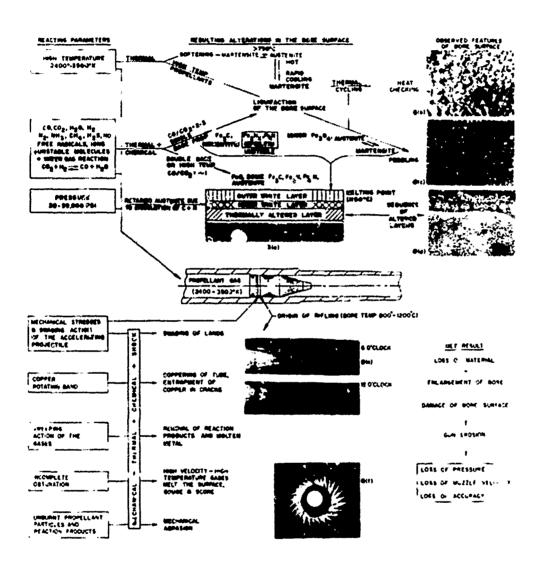
Figure 4 summarises the various interacting parameters to which the bore surface is subjected to. These include:

- 1. Temperatures as high as 2500-3500°K.
- 2. Pressures 20-50,000 ps1.
- 3. Severe chemical reactions of powder gas.
- 4. Severe mechanical atresses because of 2 and swaging action by the accelerating projectile.
- Sweeping action of gases on the softened or chemically interacted bore surface.
- 6. Improper obturation resulting in high velocity and high temperature gases streaming past the projectile.
- Abrasive action of the unburnt powder or loosened gasmetal reaction products.
- 8. Combined action of any or all of the above conditions.

Further complexity is added by the fact that these conditions vary along the length of the tube. The severest conditions occur near the origin of the rifling (O.R.) and, therefore, this is the most affected area in the tube. Erosion at the muzzle could critically influence the exterior ballistics, but the muzzle erosion is generally very little as compared with O.R. erosion.

Consequent to the volume changes on rapid heating and cooling of the surface, also involving phase transformation, stresses are developed at the bore surface which are relieved by the cracking of the surface. This condition is called heat checking (Figure 4b). It is further aggravated by the combined chemical interaction and high temperature (higher than the m.p. of the product formed at the surface) causing pebbling (Figure 4c), especially in the forward part of the chamber.

The powder gases react with the thermally altered layer and form a thin layer of the product called "white layer" (Figure 4d). Its composition varies with the history of firing, nature of the propellant, and the tube temperature. With a single base propeilant, the major products formed are Fe₃C (cementite), Fe₂N_{χ} (epsilon), and Fe₄N (τ prime), some austenite stabilized by the dissolved C and N, and martensite phase formed on rapid cooling of austenite. Fe₂N_{χ} and Fe₄N are unstable at the temperatures of firing. Therefore, these possibly form during the cooling time by the interaction of NH₃ with the bore surface.

The high velocity gases following the projectiles, heat the surface and sweep the softened or molten material from the bore surface and enlarge its diameter (Figure 4e). Under extreme conditions, actual rippling or formation of "tongues" of molten material is observed. Frequently, incomplete obturation by the rotating band results in very high velocity gases streaming past the projectile which gouge or score the material (Figure 4f). The hot gases will also soften the copper rotating band which, as the projectile moves, results in coppering the bore especially towards the muzzle end. Some of the entrapped copper in the heat check cracks may accelerate their propagation in the body of the material. Further, the accelerating projectile swages the bore, especially the land at the O.R.

Figure 4. Summary of the Processes Leading to the Erosion of a Gun Tube at the Origin of Rifling.

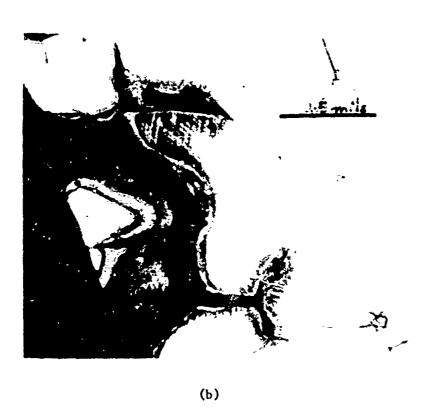
The fluctuations of these conditions on the bore surface contribute to the initiation of cracks in the bore which are very critical to the fatigue life of the tube. At the Watervliet Arsenal a capacitor-discharge system (PULSER) has been built to achieve heating rates up to 10^7 °C/sec and cooling rates of 10^5 °C/sec. Using this device, it has been shown that in 4340 steel, the grain boundaries can melt at a much lower temperature (600°C) than the m.p. of steel, thereby loosening the grain which can be easily sheared by the fast flowing gases. The concept is schematically illustrated in Figure 5a. Figure 5b is a micrograph of the surface of an eroded tube clearly showing the melting at the grain boundaries and separation of a grain.

Figure 5. Showing the Liquation of the Grain Boundaries of the Steel at the Bore Surface. (a) Schematic Reviewentation.

(b) Observed Liquation in M60 Barrel.

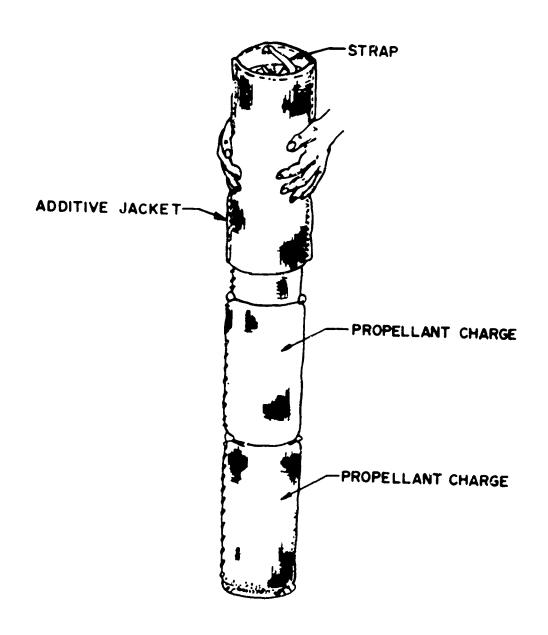
Figure 6. A View of a TiO₂-Wax Additive Jacket.

- a. Wear Reducing Additives: A sheath of rayon cloth impregnated with wax containing TiO₂ or talc particles is placed at the front end of the cartridge case or the bagged ammunition (Figure 6). On firing, the combustion products of the sheath provide a cooler laminar layer between the powder gas and the bore surface. A polyurethane foam jacket has also proven to be very successful. This technique has worked dramatically in some culibers but not as well in others. Improvement of barrel life as high as 60-100 times has been reported. At this stage no explanation is available because the exact mechanism of the action of the wear reducing additive is not known. Whether TiO₂ or talc act as only dispersants of wax or contribute in some way by absorbing energy or altering the bore surface or the gas composition at the surface is debatable (13).

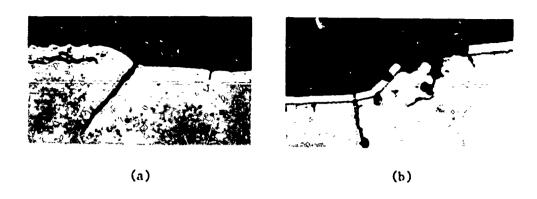
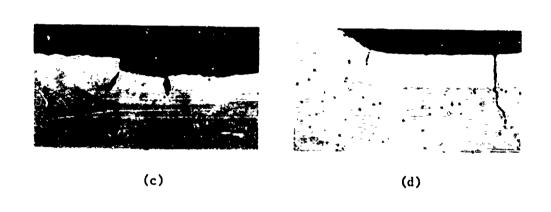
particles applied by electroplating are being evaluated in the M14 rifles. As shown in Figure 7c, which is a view of a barrel surface after 3500 rounds, Co-A1203 coating does provide protection to the substrate from the erosive environments, acts as a crack arrester and, unlike chronium, it is relatively ductile and does not flake off. Increasing the alpha A1203 content reduces erosion, but makes the coating susceptible to cracking (Figure 7d). For comparison, the surface of an uncoated tube subjected to the same number of rounds is shown in Figure 7a. However, this work is still in the preliminary stage. Other materials including tungsten, superalloys, and various refractory alloys are being evaluated at a number of R&D centers in the United States. So far, no material which is entirely satisfactory has been reported.

Figure 7. Showing the influence of Co-Al₂O₃ coating on the bore surface of 1.7.62mm rifle after firing 3500 rounds.

(a) Uncoated tube. (b) Coated with chromium. (c) Coated with Co-Al₂O₃ (2%). (d) Coated with Co-Al₂O₃ (3-4%).

- Erosion Resistant Materials: A very large amount of effort during the last fifty years has been expended to reduce erosion by either improving steel, or using coatings or liner materials with superior erosion resistance. The approach has been essentially empirical. Erosion gauges which, generally, do not simulate gun conditions or actual firing tests, have been used to evaluate the materials. During 1941-45, considerable work was done in this area. The most successful material found was Stellite 21 which was adopted as a liner material for machine guns and is still being used. However, its low melting point has been a limitation when high temperature propellants are used. Mo, especially Mo + 0.1 Co, was indicated as the ideal material, but the technology of fabrication of liners or application of coatings was not developed enough for its successful application. Chromium, which can be easily electroplated, is excellent crosion resistant material, but it is very brittle and as-plated is highly stressed and micro-cracked. On firing, it cracks and flakes off (Figure 7b). Presently, at the Watervliet Arsenal, coatings of cobalt containing 1-4% Al203
